# USING MOTOR CURRENT SIGNATURE ANALYSIS TO DETECT THE NUMBER OF BROKEN ROTOR BARS IN INDUCTION MOTORS

Mohamed Diaaeldien Hussien Wahba

Ezz Steel Industries

Fume Treatment Plant – ID Fan Motor # 2, EzzSteel, Suez, Egypt

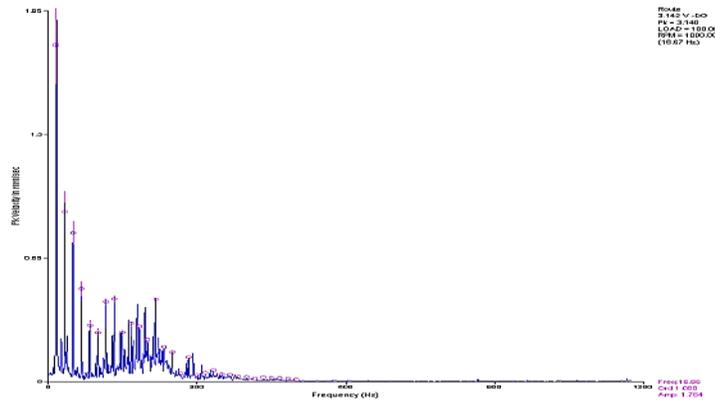
Spectral data for this motor was very common for most of vibration analyst, residual rotating looseness presented in 1x turning speed, and its harmonics. According to this information, its not evident to diagnose a critical event in the motor.

Fig 2- Motor Spectrum shows Some looseness

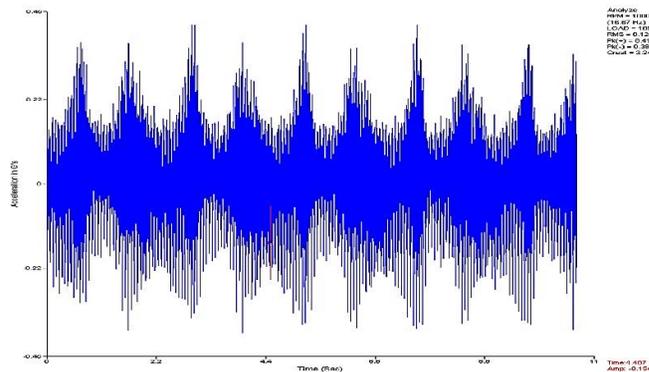
While spectral data doesn't show a serious problem, going through the time -domain data gives more insights for this case. Amplitude modulation is very clear in the waveform, and this is a serious indication that should be considered in our analysis, after all, that's why we see the sidebands.

Fig 3- Motor Time-Domain Data

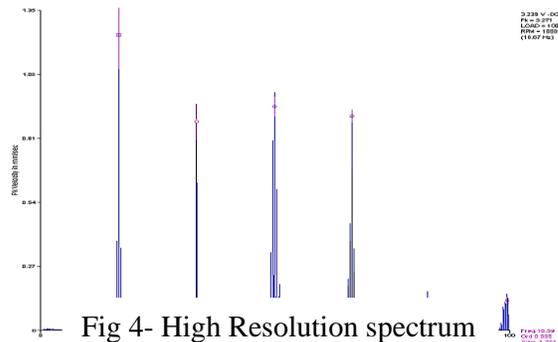
I asked for a high-resolution spectrum with a lower Fmax to be taken as this was not normally collected as part of the route. This spectrum has a Fmax of 100 Hz and with 6400 lines. You can now see that those peaks of 1X, and harmonics we saw are not simple peaks – they are broad because of the sidebands surrounding each of the peaks. With limited resolution,

Fig 4- High Resolution spectrum

there is no way to tell that those sidebands are present.

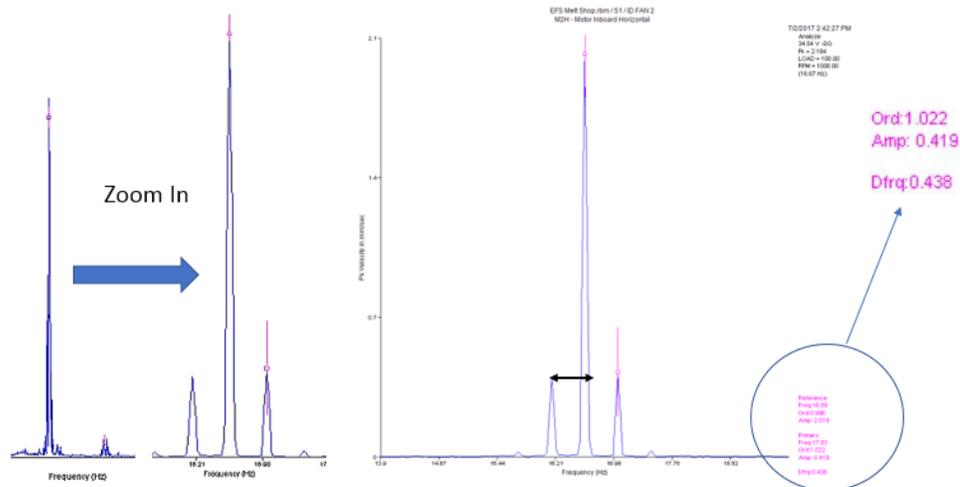
Zooming in at one of these 1xs', then you can obviously see the sidebands, and consequently detect the frequency of these sidebands. This is definitely the core part of the analysis that led you to the rotor bar problems.

Fig 5- High Resolution spectrum

Now the clue comes from the sideband frequency, as we see in the spectrum, the difference between the fundamental frequency and the left sideband is 0.438 Hz. This small value will lead us to introduce the terminology of “Pole Pass Frequency”. Until further illustration for this term in the following pages, I will introduce the following terms, and calculations:

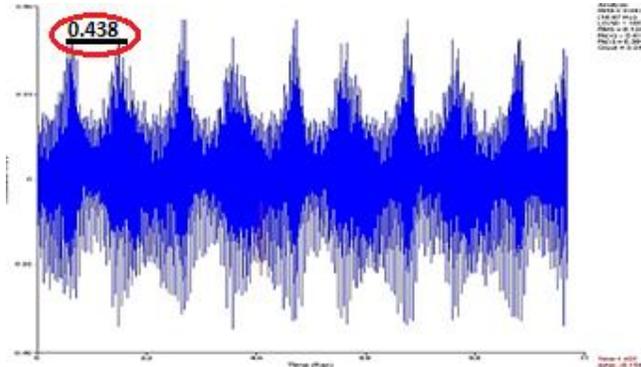
Again, the difference in the time-Domain between any two peaks gives the same  $F_{pp}$ , which is 0.438 Hz, this means that the running speed (1X) is modulated by the pole pass frequency.

Fig 7 – 1X is Modulated by  $F_{pp}$

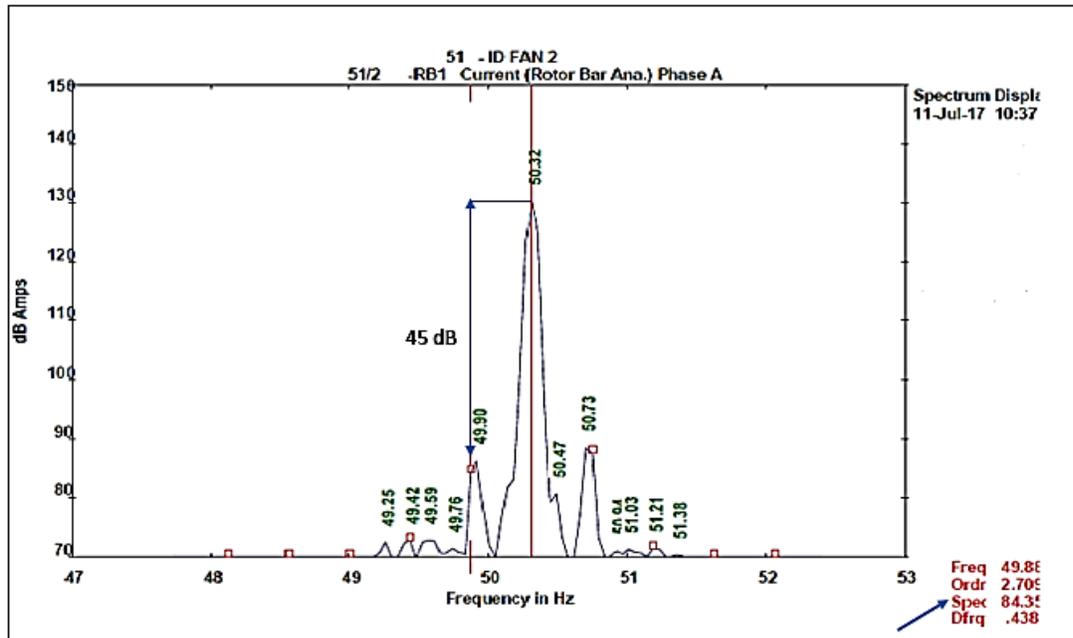
Fig 9- Current Signature frequency domain on 11-July 2017 Shows 45dB difference between line frequency Amplitude and Left sideband Amplitude.

In Fig 9, we can see the line frequency (50Hz) recorded an amplitude 130 dB approx., and two obvious sidebands which reflect the existence and the severity of the rotor bar defect. The amplitude of the left sideband as shown in red data recorded 84.35 dB, this value increase as the defect becomes more severe. In this signature which had been taken on 11-July -2017, the difference between the height of the line frequency 50Hz, and the height of the left first sideband was 45dB, this value is our indicator of rotor bar deterioration.

According to the previous table, the condition of the rotor bars of this motor is at a stage which needs a very close monitoring, the suspicion of cracked rotor bars exists. As a result, the frequency of the measurements has been increased to be twice per week and we introduced thermography activity to detect any expected overheat.

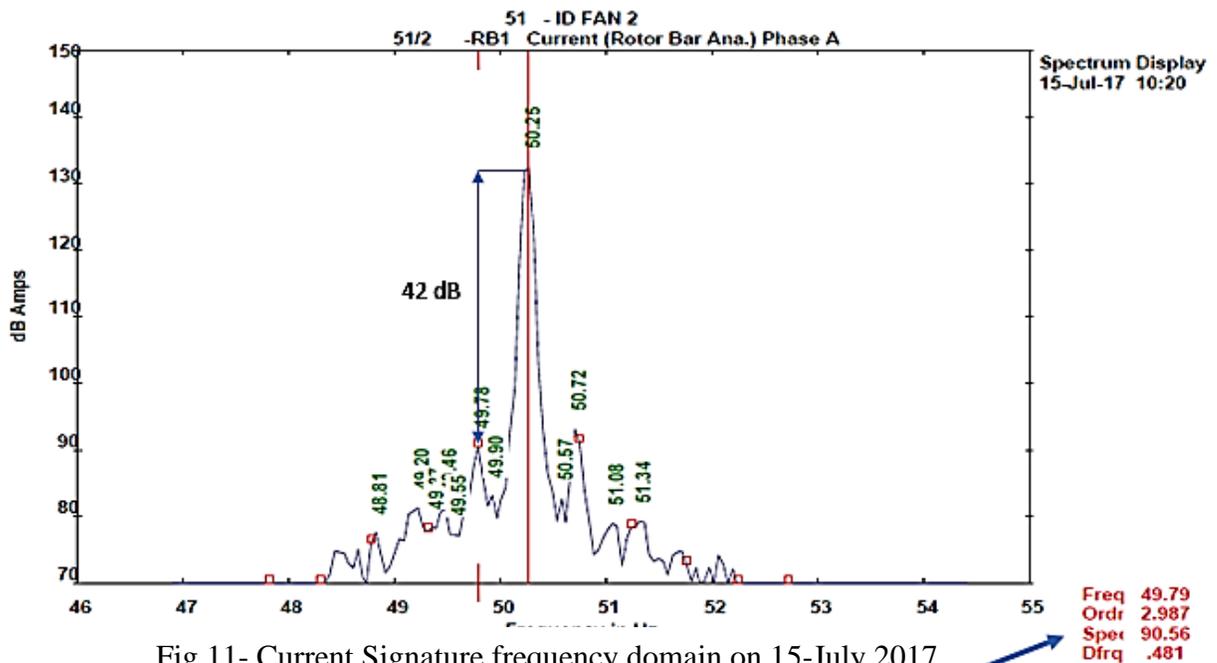
After few days, we captured a new current signature to figure out the status of the dB value, the measurement conditions were the same and surprisingly the dB values dropped from 45dB to 42dB. This was a serious alarm for the bars condition and the deterioration rate. Moreover, the height of the lower sideband on the left side of the line frequency increased from 84.2 Hz to 90Hz, this indicates the rotor bar defect frequency and how the severity increases by the time. At 42dB, we can expect one rotor bar breakage. At this stage we issued our recommendation to stop the motor and pull it out to the workshop for immediate inspection, but unfortunately due to some production due dates we could not stop this motor. We increased the frequency of measurement either vibration or current signature to be on a daily-basis. We could notice the drop of dB value week by week.

Fig 11- Current Signature frequency domain on 15-July 2017 Shows 42dB difference between line frequency Amplitude and Left sideband Amplitude.

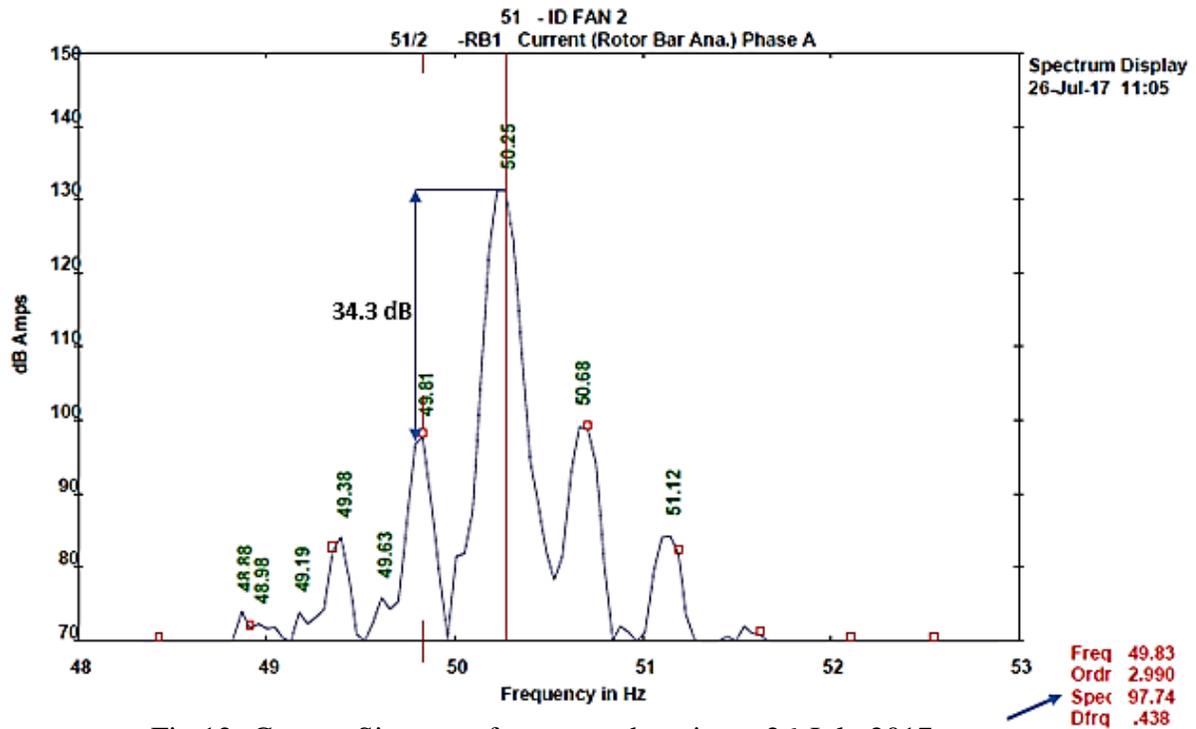
On 26<sup>th</sup> July-2017, the dB value dropped significantly to 34.3dB. At this stage -even its too late-, we decided to stop the motor and pull it out from the operation and send it to the workshop for inspection. You can clearly hear the humming sound close to motor area, and feel the beating you already see in the waveform.

Fig 12- Current Signature frequency domain on 26-July 2017  
Shows 34dB difference between line frequency Amplitude and  
Lower Left sideband Amplitude.

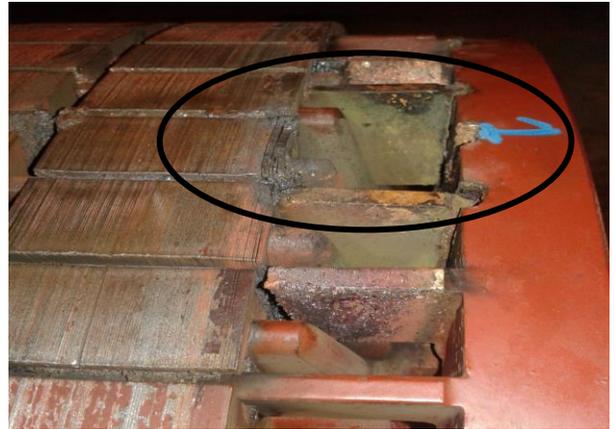
By Pulling the motor out to the workshop and inspect it we found a completely broken bar fallen from its position on the rotor, three cracked bars, and parts of melted lamination.

Fig 13- One completely Broken Rotor Bar in The Motor

It was therefore predicted that there was definitely one bar completely broken. There was also a risk of the broken bar lifting out of the slot with consequential mechanical damage to the stator winding.

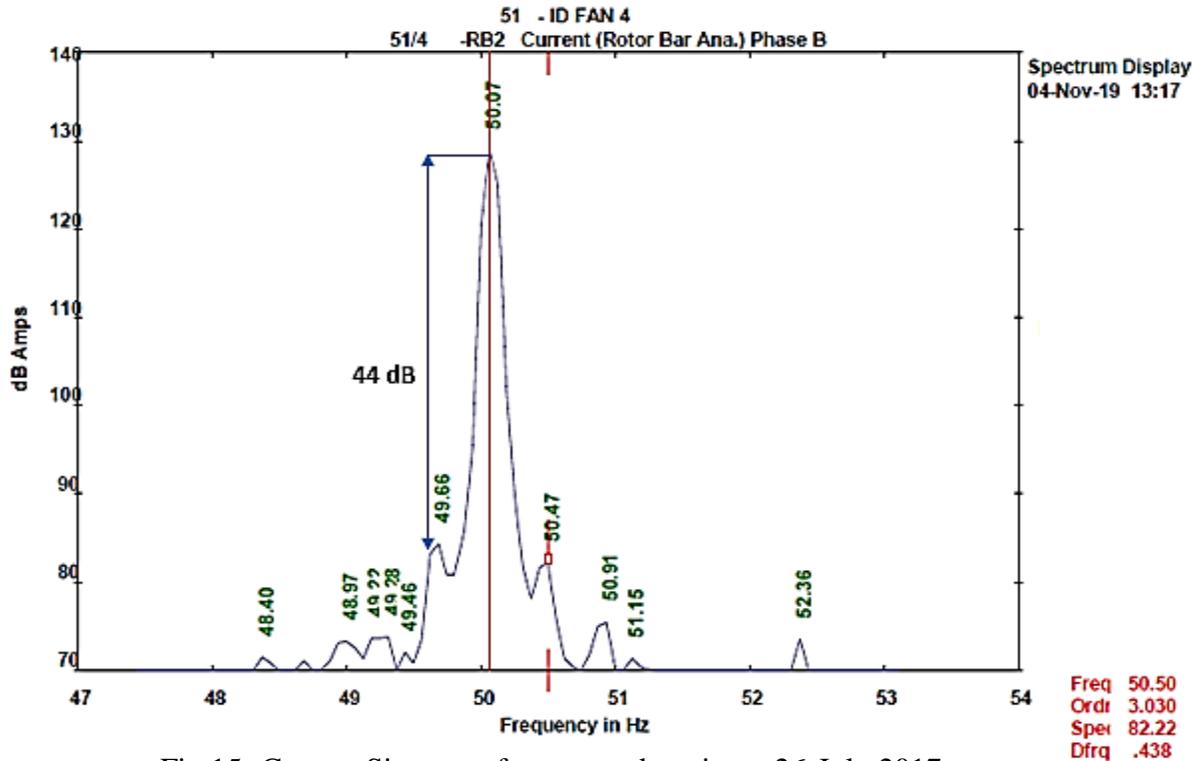
In this case the dB value was 44dB, but we decided at this stage to pull out the motor to workshop to mitigate any further risk, and to avoid any damage as we experienced in the Case 1.

Fig 15- Current Signature frequency domain on 26-July 2017 Shows 44dB difference between line frequency Amplitude and Lower Left sideband Amplitude.

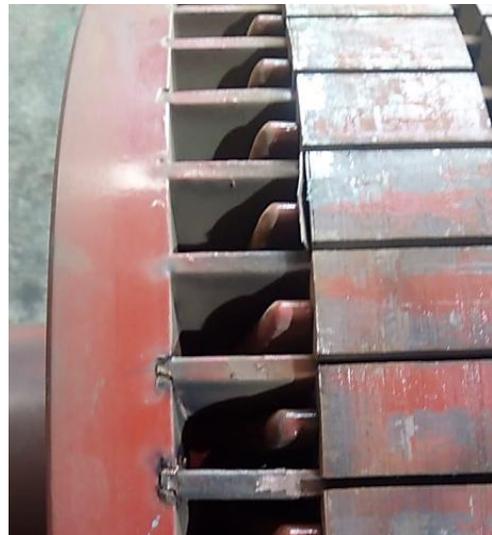
In this case, we could catch the severity level very early and the equation again proves the prediction of the existence of only cracked rotor bars, an no broken bars.

Fig 16- Two Cracked Rotor Bars
