# USING MOTOR CURRENT SIGNATURE ANALYSIS TO DETECT THE NUMBER OF BROKEN ROTOR BARS IN INDUCTION MOTORS

Mohamed Diaaeldien Hussien Wahba

Ezz Steel Industries

Fume Treatment Plant – ID Fan Motor # 2, EzzSteel, Suez, Egypt

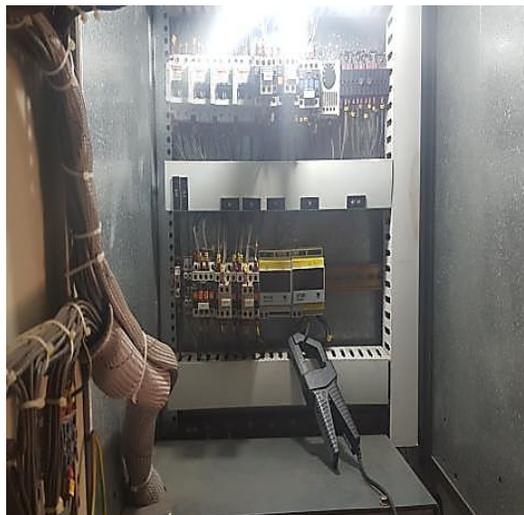
3.2.2 Data Interpretation – First Snapshot: Fig 8- Collecting Current Signature Using  
CSI Ampere Clamp & CSI Analyzer.

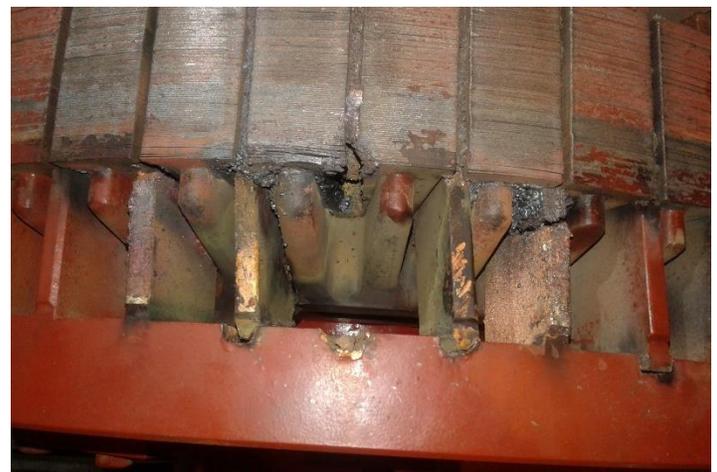
By Pulling the motor out to the workshop and inspect it we found a completely broken bar fallen from its position on the rotor, three cracked bars, and parts of melted lamination.

$$N = 1.24 \text{ Bars}$$

It was therefore predicted that there was definitely one bar completely broken. There was also a risk of the broken bar lifting out of the slot with consequential mechanical damage to the stator winding.

Fig 14- The Equation validates the one broken bar existence.
